Aspects Regarding Vegetation on and at Levees

R. Haselsteiner

Bjoernsen Consulting Engineers, Koblenz, Germany

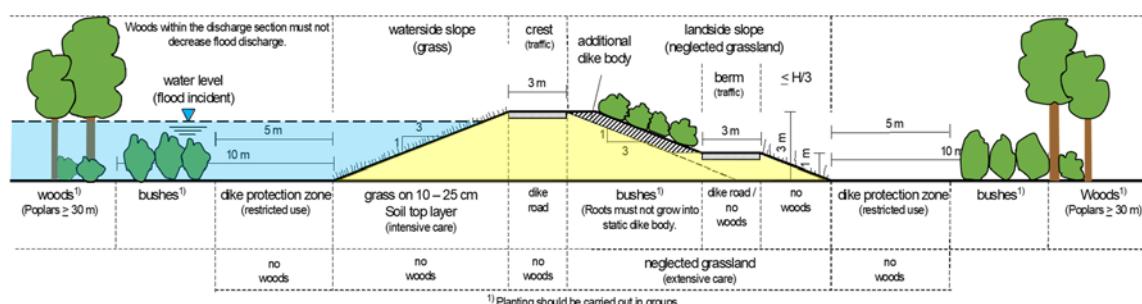
The general layout of a dike/levee section is shown in Figure 1 which reflects the standard case. The levee shows the minimum required geometric layout in order to fulfill the stability and durability requirements. In general, the levee itself should be free of woody vegetation including a dike protection zone of 5 m at both toes. Only the upper part of the downstream slope may host small bushes when the embankment shows a protective additional fill. Trees should show a minimum distance of 10 m and very large, strongly rooting, and fast growing trees, such as poplars, should stay minimum 30 m away from the dike toes. Bushes may be placed at a distance of 5 m in fore- and hinterland. All other zones and areas are to be covered by roads, revetments, ways, etc. or "simply" a vegetation layer in form of a strong rooted sod.

Figure 1. Standard levee/dike section with zones describing mandatory and tolerable forms of vegetation according to DIN 19712 and DVWK-M 226/1997 (taken from Haselsteiner, 2019)

As shown in Figure 1 on and at normal “standard” levees the upcoming, growing or planting of woody vegetation in form of bushes or trees is avoided, in general, since also DIN 19712 and related guidelines are quite strict in the formulation mainly in respect to the standard case of a levee. But, as aforementioned, for exceptional cases woody vegetation is allowed if some precautionary measures are taken, e. g., the application of static systems/elements which are guaranteeing the stability of the levee also in case of a tree failure, or the oversizing of the embankment, so that the trees may fail without showing an effect on the static required levee body and on the flood safety at all (Kerres & Haselsteiner, 2018; Haselsteiner, 2018C).

In consideration of the general regulations for the standard case which are illustrated in Figure 1, the exceptional cases will be regulated more in detail in DWA-M 507 Part 2 which is still in preparation. The evaluation matrix which is shown in Figure 4 shall enable to prepare project specific designs in consideration of structural “safety” measures such as the application of oversize sections or static elements such as steel sheet piles. Line 1 represents the “standard case” as shown in Figure 1, the other three cases are “exceptional cases” which allow the appearance of trees almost everywhere in consideration of the safety measures except on the ways and roads (line 4) as an extreme counterpart solution to the “standard case”.

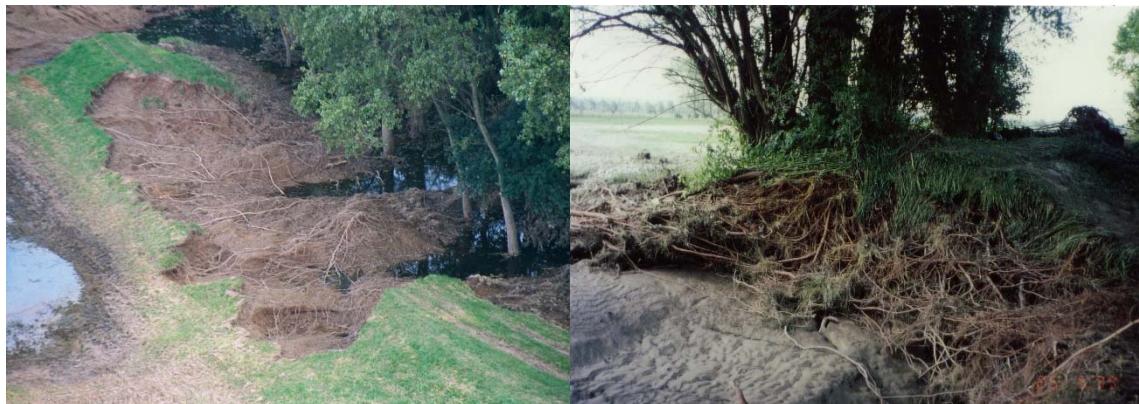
The up-to-date regulations result from elaborate works, e. g., performed in the 1970s and 1980s in Bavaria where many trees on levees were mapped, inspected, and partly excavated in order to determine the extension of roots through levees (LfW BY, 1990). The results were quite surprising since the trees developed a complete different root system compared to the genetic codification. Once you understand the tree as a living organism this reflects just the trees' adaptation for survival in respect of the environmental conditions, such as water, light, nutrition, mechanical resistance, etc. and the physical needs of the tree which is also comprising the stability of the tree itself. In Figure 2 some selected examples for extensive roots in levees are shown which shall provide an impression of the potential intensity of root systems in or though levees.

Figure 2: Roots through levees exhibited after dike breaches (left: failed dike at the River Mulde 2002, Source: Landestalsperrenverwaltung Sachsen / right: dike breach at the River Ammer in 1999, Source: WWA Weilheim)

In reported cases (see also Figure 2) levees failed where trees were located, but whether the tree was the reason for failure or the tree and its roots did slow down the failure process cannot be evaluated afterwards since the subject of interest is gone and all attempts for the description of the actual failing procedure would be pure speculation.

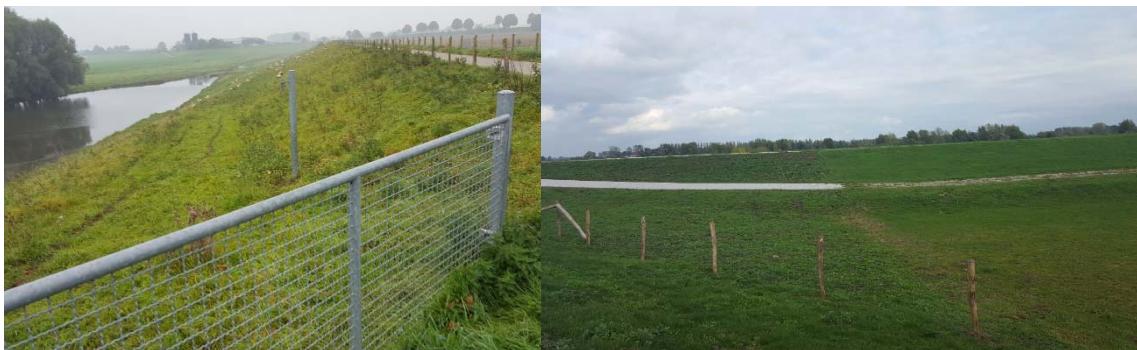
Two selected pictures of grass covered levees are shown in Figure 3. Where sheep grazing was applied the vegetation shows irregularities, which does not mean that this specific surface condition is not fit for purpose (left picture). The right picture illustrates the result of effective cultivation works on the right and "not so" effective results on the left which can be clearly identified by the visible grass mass.

Figure 3: Vegetation layers in form of grass covers of selected case studies (left: upstream slope of Rhine main levee in 2017 with sheep herd in the back / right: downstream slope of a Rhine levee showing different management/cultivation measures from 2019 / Source: BCE)

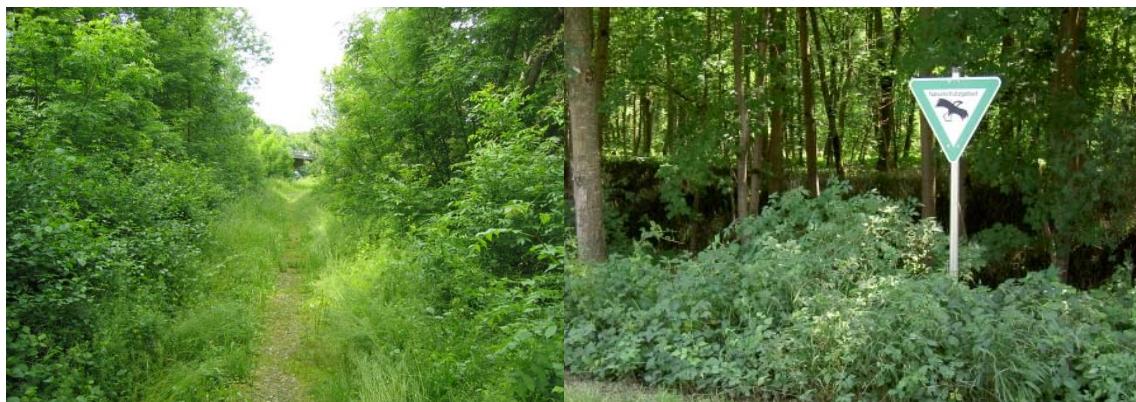
In this overall context it has to be also mentioned that especially for the allowance of trees on and at levees always a specific case-by-case analysis have to be performed. For example, for some levees in Bavaria which protect “only” agricultural areas a dike breach is accepted also in consideration of the occurring small damage so that neither the stability of the dike nor supervision, maintenance, and defense are required. These levees are not maintained and through the years are completely covered by large trees and woods (Figure 5).

Figure 5: Extensive woody vegetation on levees on Bavaria (left: wooded dike at River Iller (Bavaria) near Altenstadt with a trail on dike crest, Source: TU Munich / right: complete wooded dike at River Danube near Dillingen in a nature protection area, Source: StMUGV, a ministry of Bavaria / both taken from Haselsteiner, 2019)

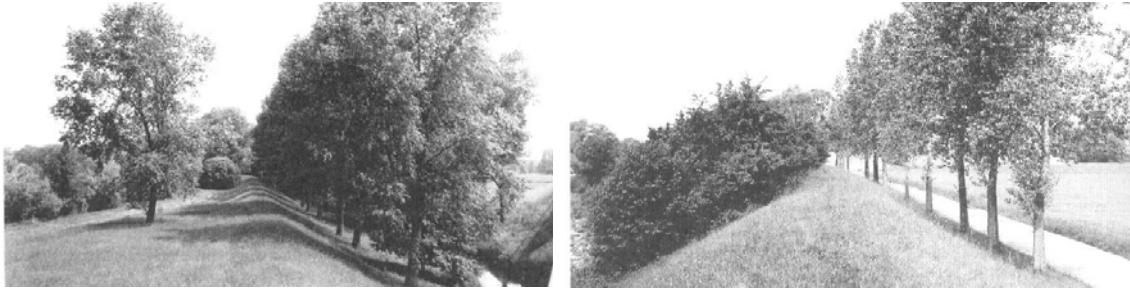
Decades ago trees were planted on levees on purpose in order to stabilize the embankments as shown in Figure 6. Mostly alleys were applied which were also instruments of landscaping. In

order to have a quick effect fast growing trees were selected which are the most dangerous trees according to the experience and knowledge of today.

Figure 5: Planted trees and alleys on old levees in Germany (left: flood protection dike at the river Koessnach near with poplars and meadow, 1985 / right: flood protection dike at the river Danube with landside poplar row and waterside bushes and grass/meadow, 1985 / taken from Pflug & Hacker, 1999)

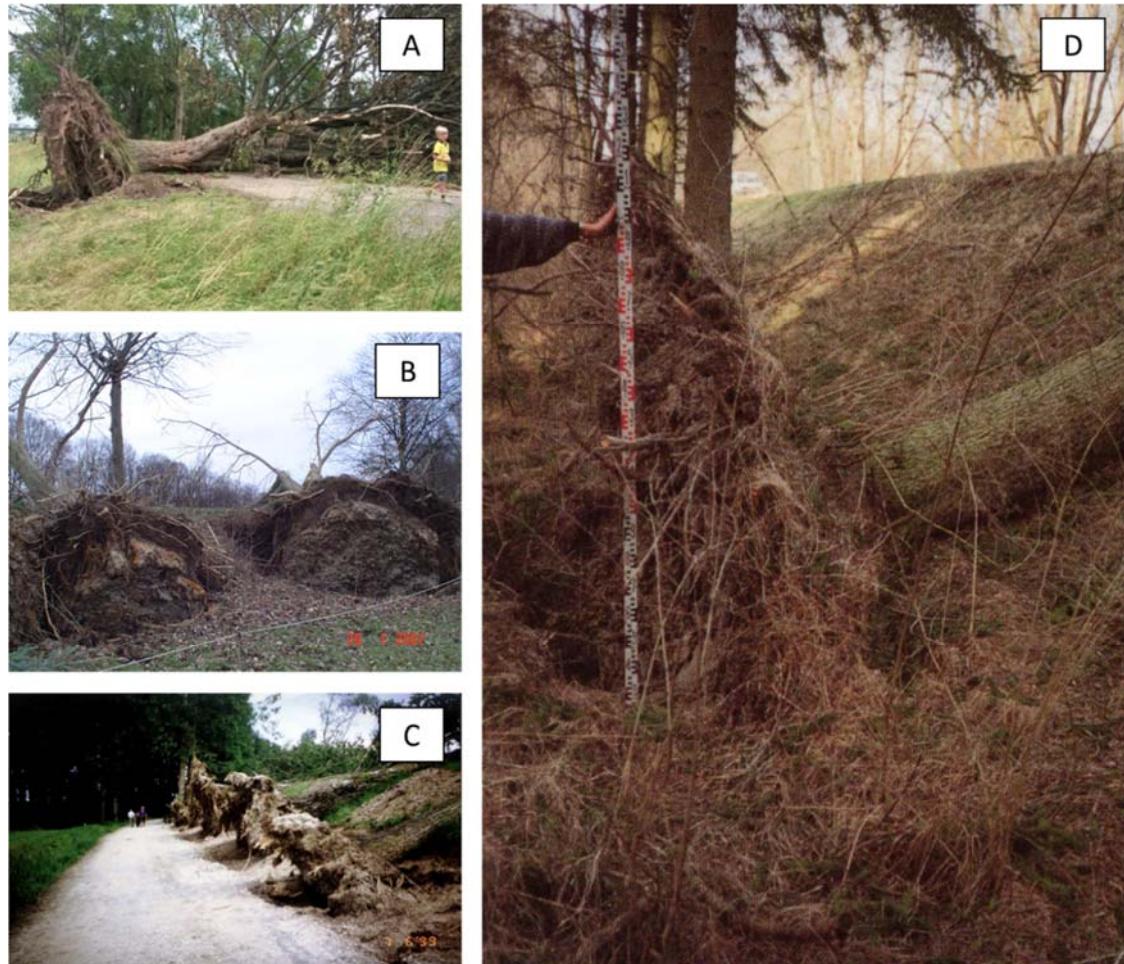
The failure of trees cannot be always predicted or evaluated accurately enough, as many failures show during storm events in the last decades (Figure 6). Fortunately, the tree failures did not coincide with flood events so that the levee could be rehabilitated without any major risk for flooding.

Figure 6: Selected tree failures by windthrow at levees in Germany (A: windthrow at a Rhine levee during the storm Ela 2014 in Duesseldorf, Source: SEBD / B: windthrow at levees with the Black Magpie during storm Kyrill 2007, Source: LUA Brandenburg / C: thrown row of poplars at the landside levee toe in 1999, Source: StMUVG / D: Thrown spruce at the landside levee toe at the river Lech in Bavaria, Source: LfW BY 1990)

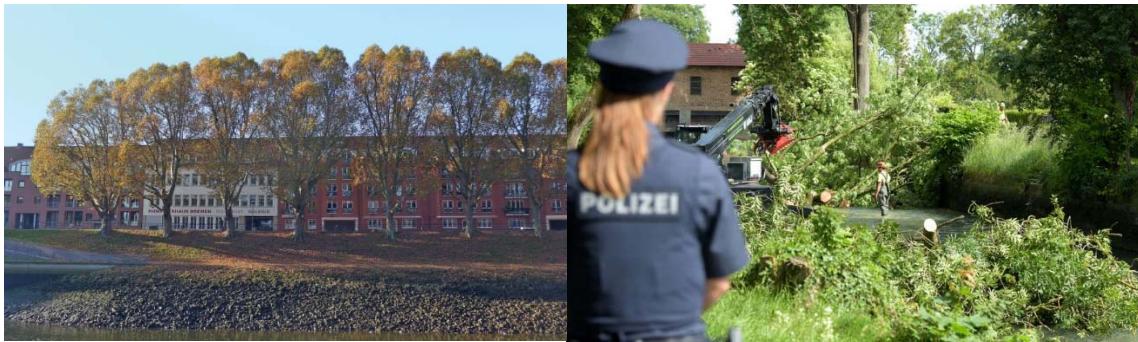
In a growing number of projects the topic trees and flood protection structures is escalating in Germany, e. g., Bremen, Mannheim, Duesseldorf, and many other places. Mainly safety considerations postulate the removal of the tree(s) and the rehabilitation of the flood protection structures whereas the objectors frequently claim the positive effects of trees, such as the improvement of stability by biological reinforcement, the provision of habitat for endangered species, positive effects on the microclimate, etc. Sometimes the hot-tempered discussion escalate so that the police needed to interfere against activists in order to protect tree felling works (Figure 7, right picture). In Bremen the design for the rehabilitation of an old levee includes the removal a row of plane trees along the Small Weser River which became a political issue reaching to the top politics of the city (Figure 7, left picture).

Figure 7: Current, public discussed levee projects in Germany (left: plane trees along the Small Weser in Bremen, Source: Wessolly, 2020 / right: tree felling works in Augsburg 2018 under the protection of police forces, Source: Münchener Merkur, dpa, Stefan Puchner)

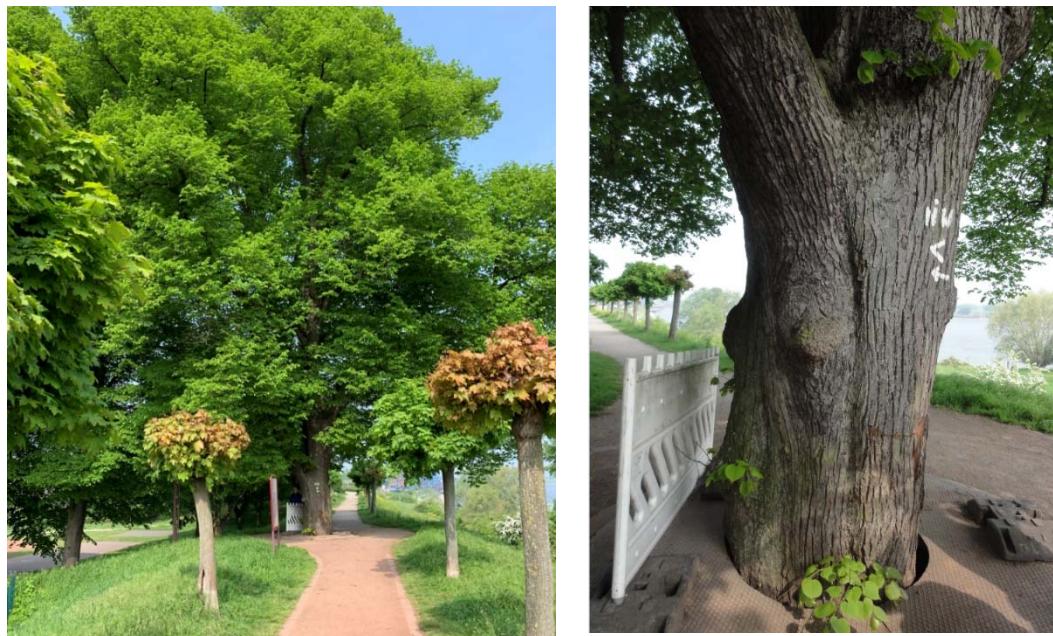
In the vicinity of the small town Orsoy at the Rhine River the presence of a linden tree/basswood is splitting the community. The tree is called “Dicker Bär” (engl.: “Fat Bear”) (Figure 8). The responsible flood safety agency identified an unacceptable, imminent risk triggered by the tree which is mainly caused by its location in the middle of the levee and its strong and large root system. The imminent risk was already attested by an expertise of an independent university.

Figure 8: Single large tree “Dicker Bär” on a levee in the vicinity of the town Orsoy at the Lower Rhine region (left: total view during summer / right: close-up of trunk, Source: BCE)

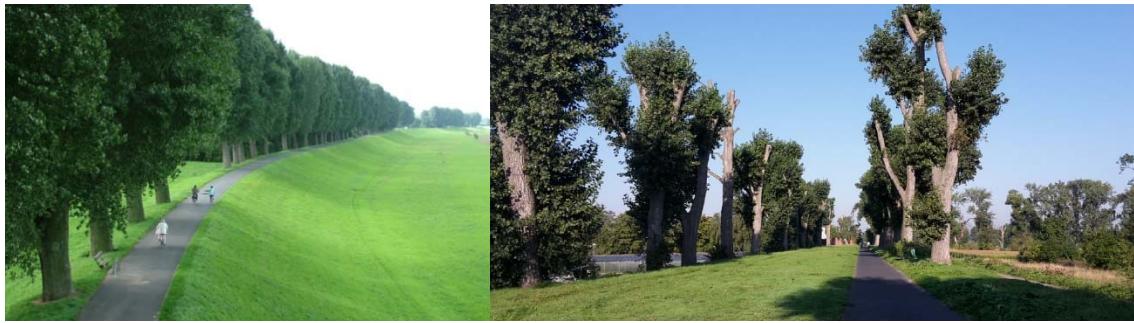
For the town Duesseldorf a study was prepared for all the flood protection structures where woody vegetation is/was close or is/was located directly on the structures. In advance approximately 4,700 trees were mapped and registered or if they were already registered the register data was updated. In Figure 9 two special levee examples are shown to provide an impression of the levees in Duesseldorf which were investigated within the mentioned study.

Figure 9: Trees on levees within the vicinity of the town Düsseldorf at the River Rhine (left: row of poplars on the crest of the “Lohäuser” levee in Düsseldorf, Source: Bezirksregierung Düsseldorf / right: poplars on the relatively wide-crested “Niederkasseler” levee in Düsseldorf – 2015, Source: BCE)

- Frequently, existing levees where already large trees are located show an oversized profile as it is shown in Figure 9. The problem with old, existing levees with large trees is that this oversized profile is not providing enough protection/safety since the dam body is likely to be strongly rooted which is considered to be harmful in respect to stability.

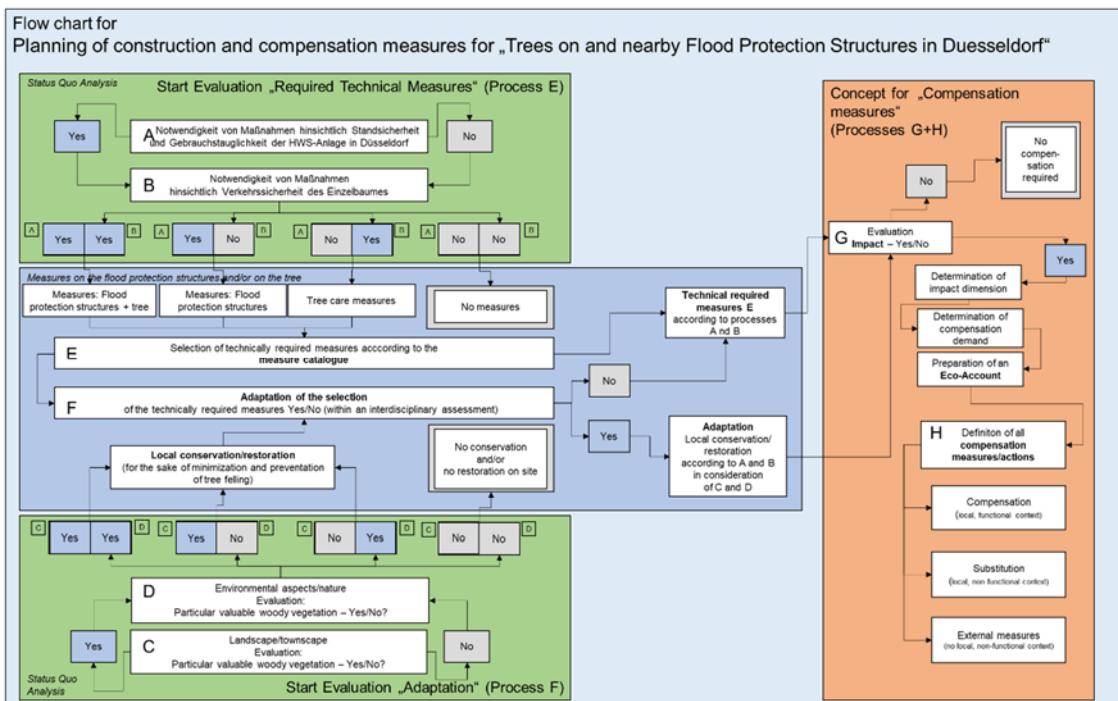
Figure 10: Flow chart of a standard procedure for the planning of construction and compensation measures prepared for the project “Trees on and nearby Flood Protection Structures in Düsseldorf” (BCE, 2019)

The mapping included an evaluation of the general conditions such as height, diameter, illnesses/diseases, age, and also residual life time. In many cases the determined value of a tree was not sufficient for claiming preservation action so that in the course of rehabilitation works a removal of the trees could be accepted when the legal, normal procedure for compensation etc. are followed up. This study (BCE, 2019) concentrated on the development of a standard procedure for handling existing and potential future woody vegetation on and at flood protection structures in the course of the realization of rehabilitation projects (Figure 10). Hand in hand with the shown flow chart a measure catalogue was prepared in order to support the selection of measures during the processes E and F.

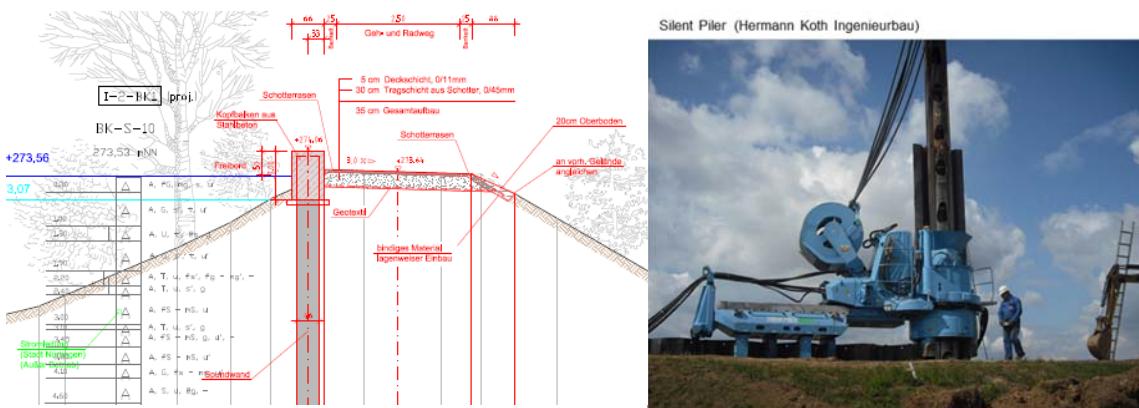
Mainly in urban areas the conservation of existing woody vegetation on flood protection structures is frequently the favorite design alternative in consideration of all interests and aspects of all project participants and stakeholders. In order to achieve the conservation of existing trees in urban conditions the application of space-saving techniques for the implementation of static elements is evident. For this purpose the self-move press-in procedure for sheet piles, as applied in harbor areas, is a suitable solution as shown in the case study in Figure 11. The existing levee is generally conserved. The trees in a distance of less than 1.5 to 2.0 m from the axis of the sheet piles will be removed which is also valid for the crown of the trees, but the rest will be also conserved.

Figure 11: Design of a levee rehabilitation along the River Neckar for the town Nuertingen in the south of Germany (left: typical cross section with a self-moving, pressed-in sheet pile, Source: BCE / right: self-moving, press-in equipment “Silent Piler”, Source: Hermann Koth Ingenieurbau)

By this design the impact on the biotopes and habitats could be minimized crucially. This minimization of the environmental impact is a key factor for the approval and realization of the

Generally, the shown case study represents a costly method compared to other ways of rehabilitation. But the comparison of the costs of the alternatives cannot be done so easily, since the favorite solution can be realized whilst the other alternatives which are showing a much larger impact cannot be realized. Thus, the theoretically cost-intensive favorite solution is still the most economic one in consideration of the avoided flood damage.
